## **REPORT ON FIRE RESISTANCE TEST OF BOARD PARTITION SYSTEM**

Client : PalmEco Tech Ltd.

Project : Fire Resistance Test on Board Partition System  
in accordance with BS EN 1364-1: 1999

Report No. : 130209FU130026

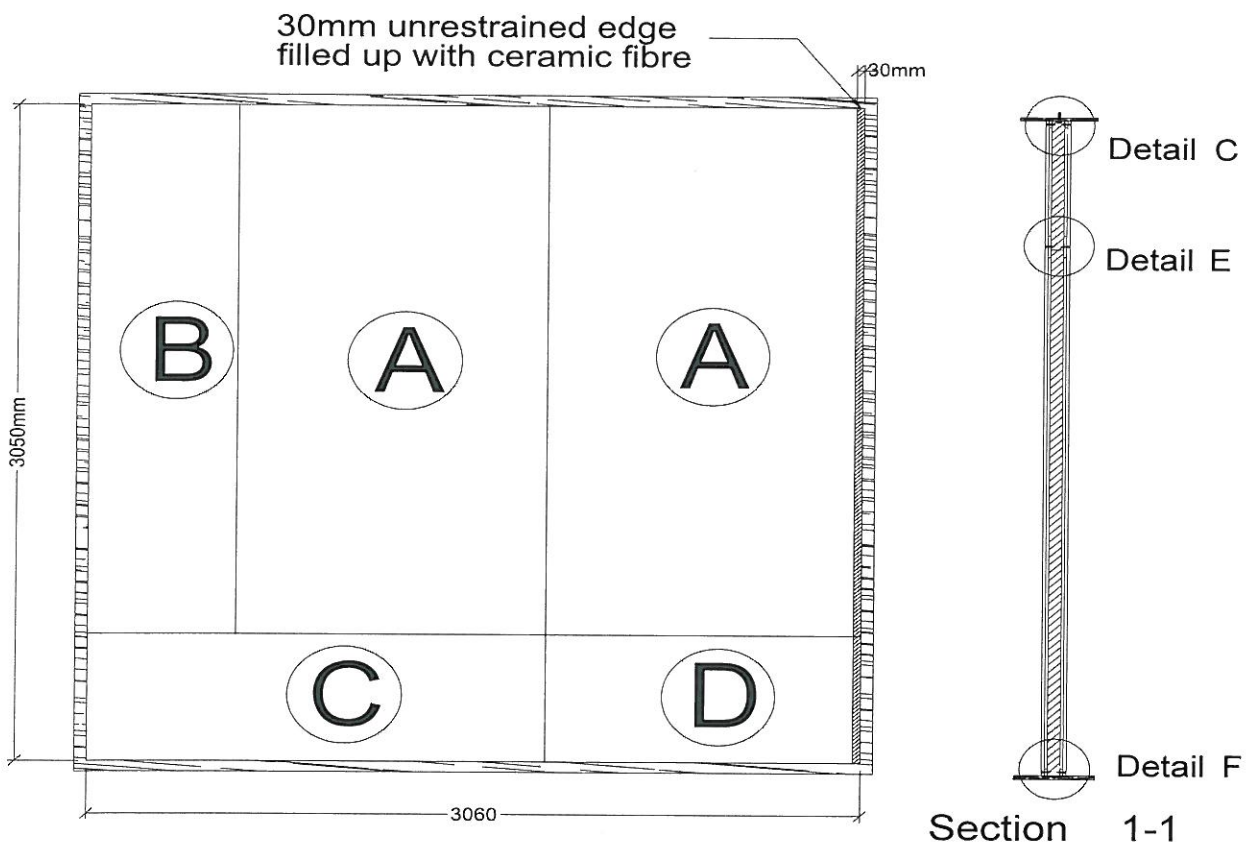
Figure 1 - Elevation of the Unexposed Surface of the Specimen

All dimensions are in mm.

All components and dimensions indicated have been verified by the Laboratory.

Description of the test specimen is shown in Schedule of Components and illustrated in Figures 1 to 6. The description is based on a detailed survey of the specimen and the information supplied by the client.

(Refer to Figure 1 to 6. Unless stated otherwise, all values are nominal, and all information in this Schedule of Components is supplied by the manufacture.)

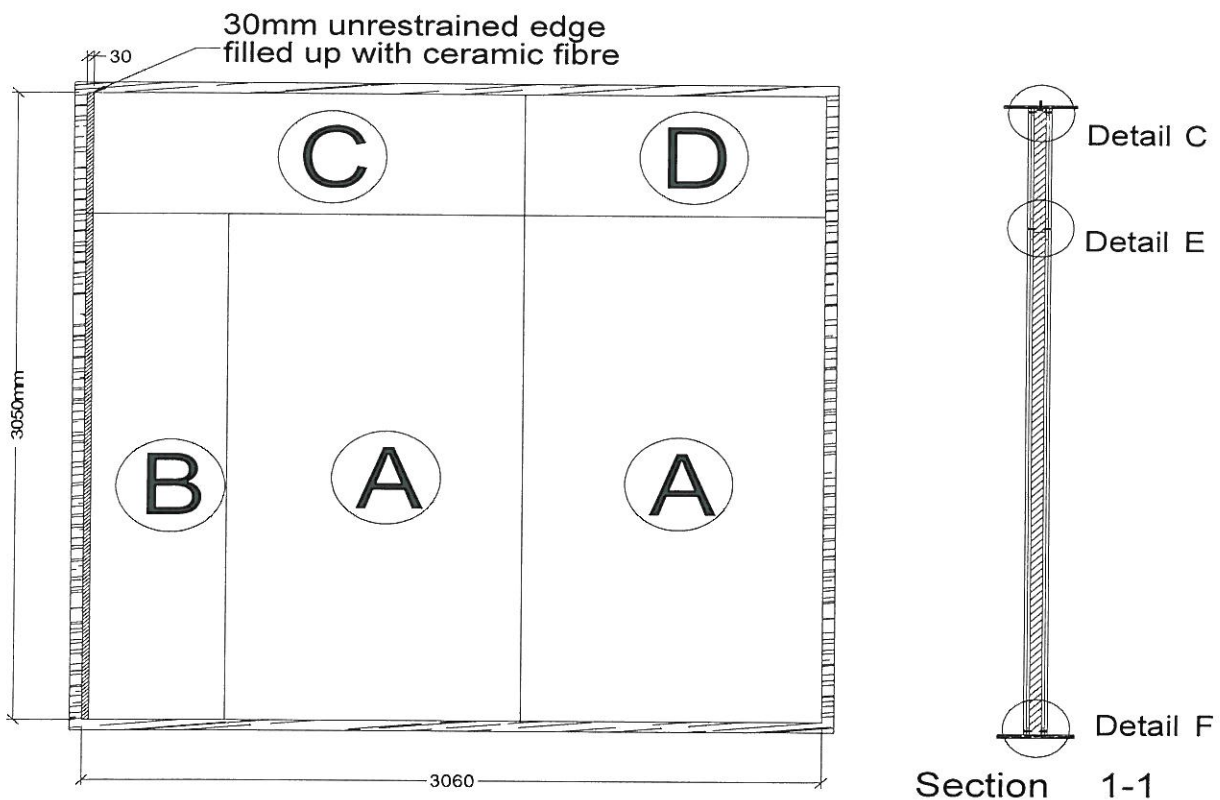
Figure 2 - Elevation of the Exposed Surface of the Specimen

All dimensions are in mm.

All components and dimensions indicated have been verified by the Laboratory.

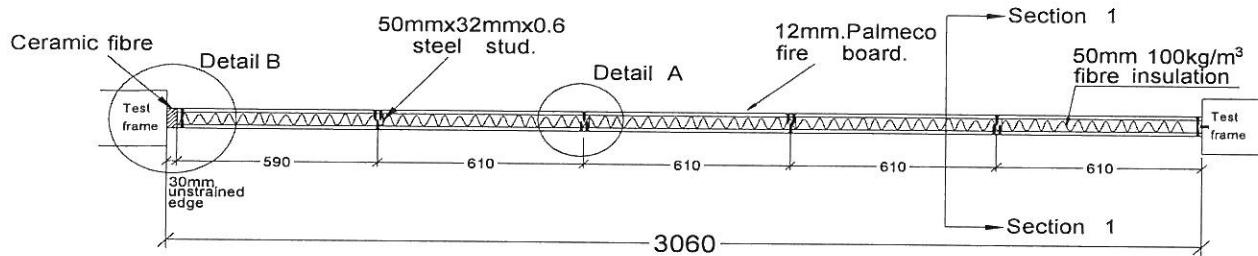
Figure 3 - Top View of the Specimen

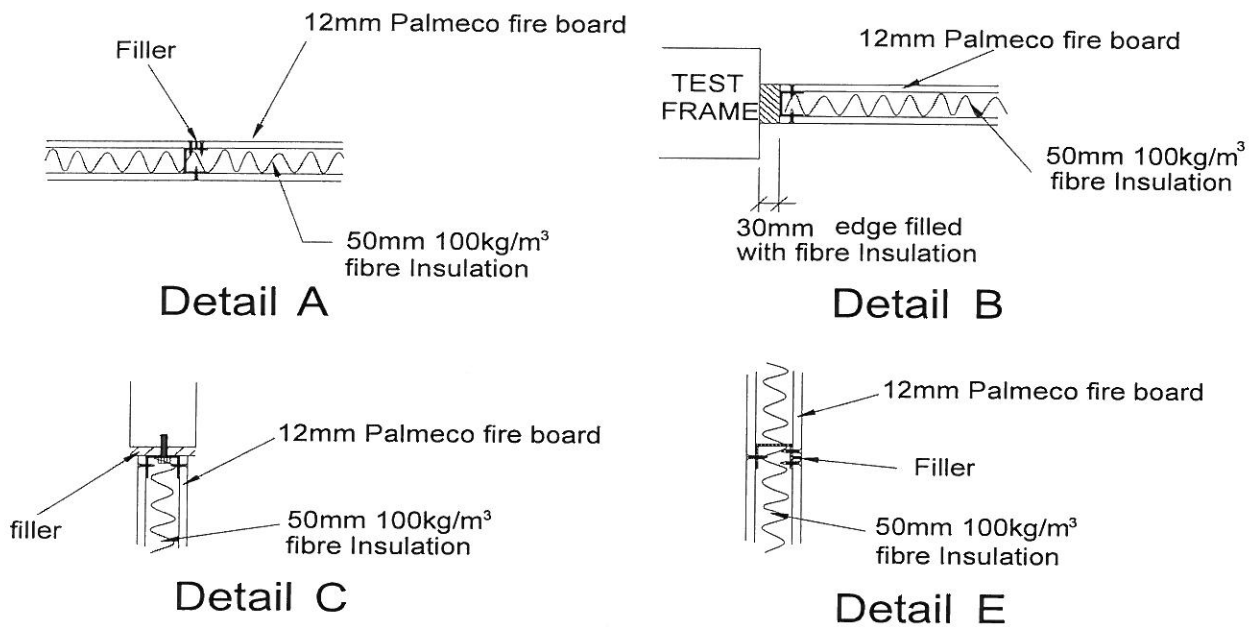
Figure 4 - Details of the Specimen

All dimensions are in mm.

All components and dimensions indicated have been verified by Laboratory.

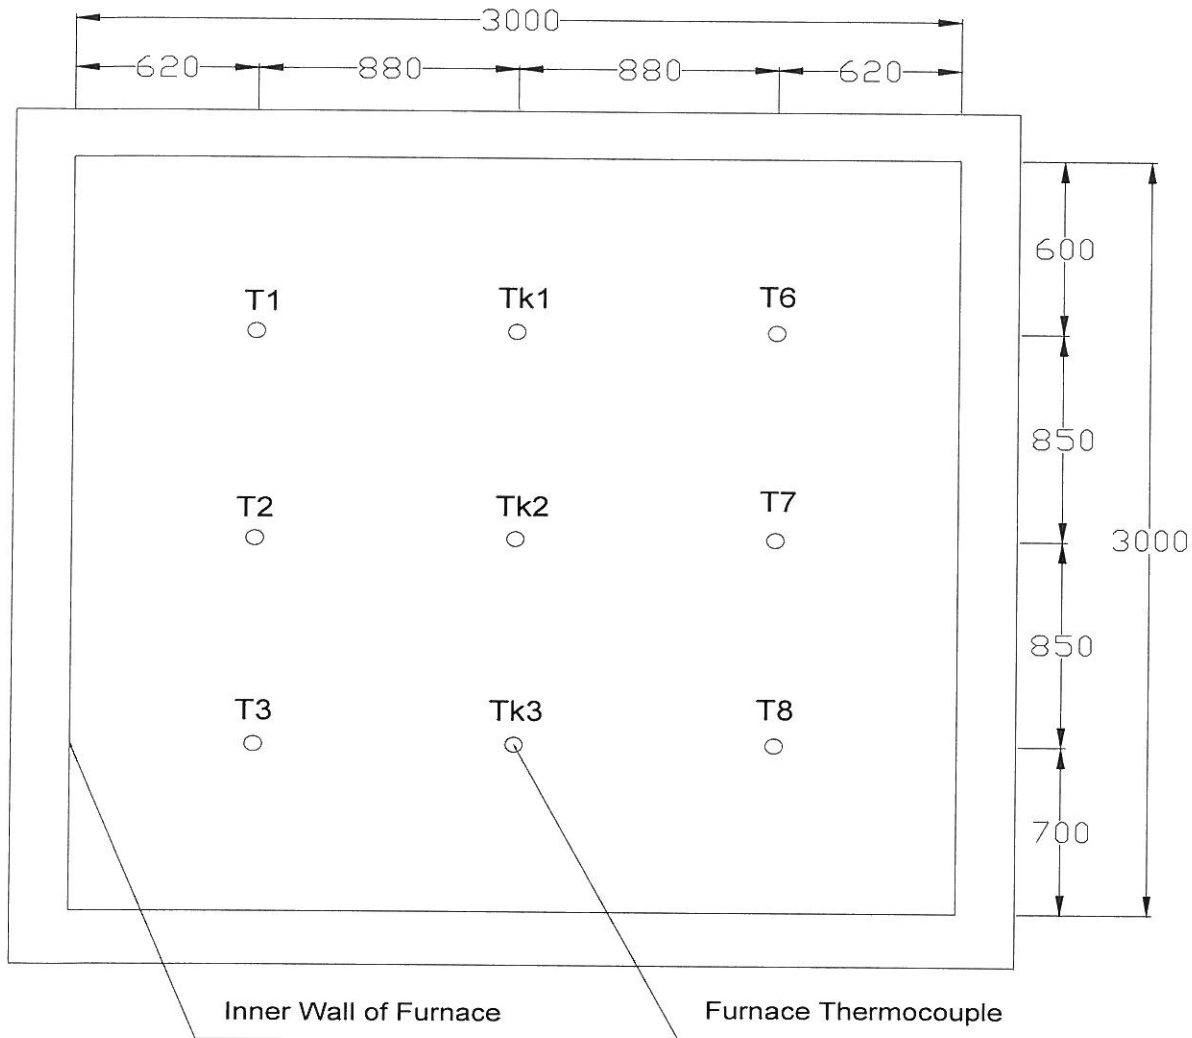
Figure 8 - Locations of Furnace Thermocouples

Nine plate thermocouples were installed and maintained 100 mm away from the exposed surface of the specimen to monitor the furnace temperature. The locations of the furnace thermocouples are shown in Figure 8.

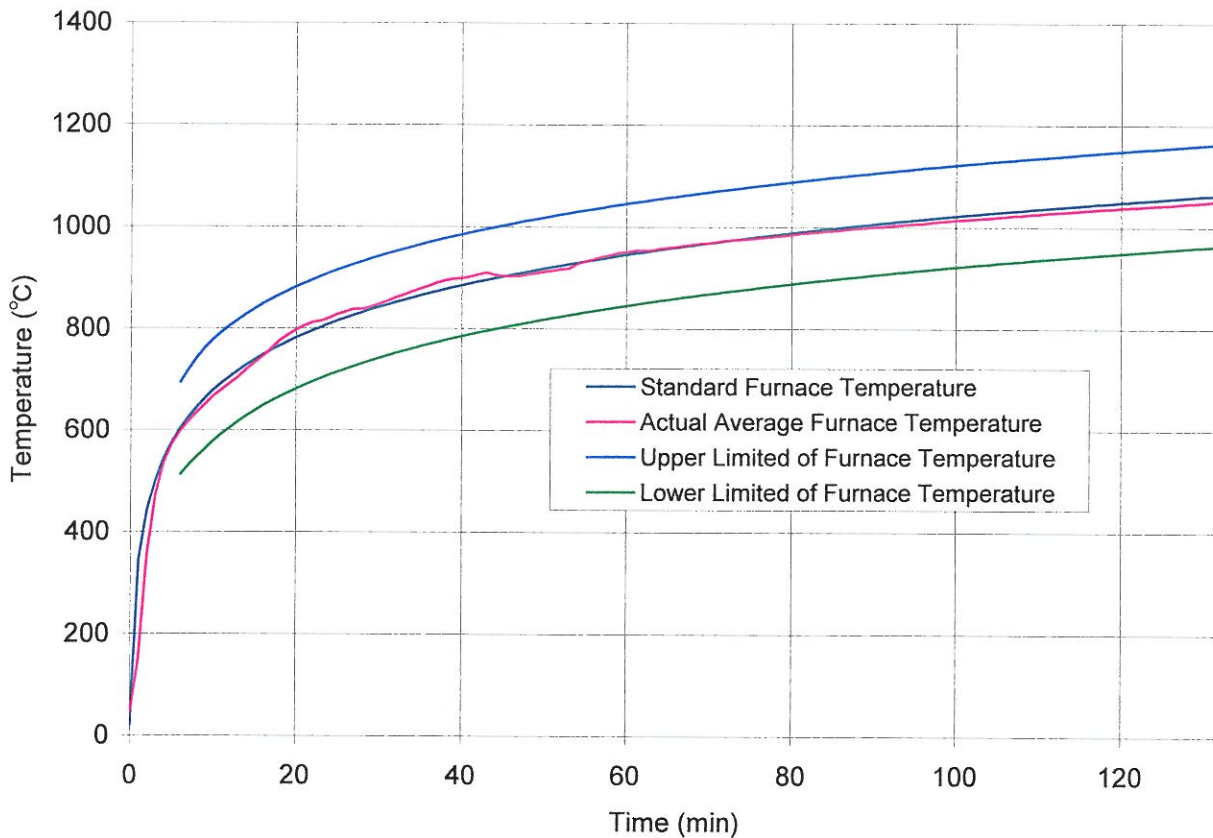
Figure 9 - Actual Average Furnace Temperature/Time Curve and Standard Furnace Temperature/Time Curve

- a) The actual average furnace temperature/ time curve as well as the standard furnace temperature/ time curve, are shown in Figure 9.
- b) The furnace pressures relative to laboratory atmosphere, at 2030 mm below the top of the specimen, are shown in Figure 10.
- c) The average and maximum temperature rises of the unexposed surface of the specimen are shown in Figure 11 and 12. The individual temperatures recorded on the unexposed surface of the specimen are shown in Table 1.
- d) The lateral deflections of the specimen are shown in Table 2.

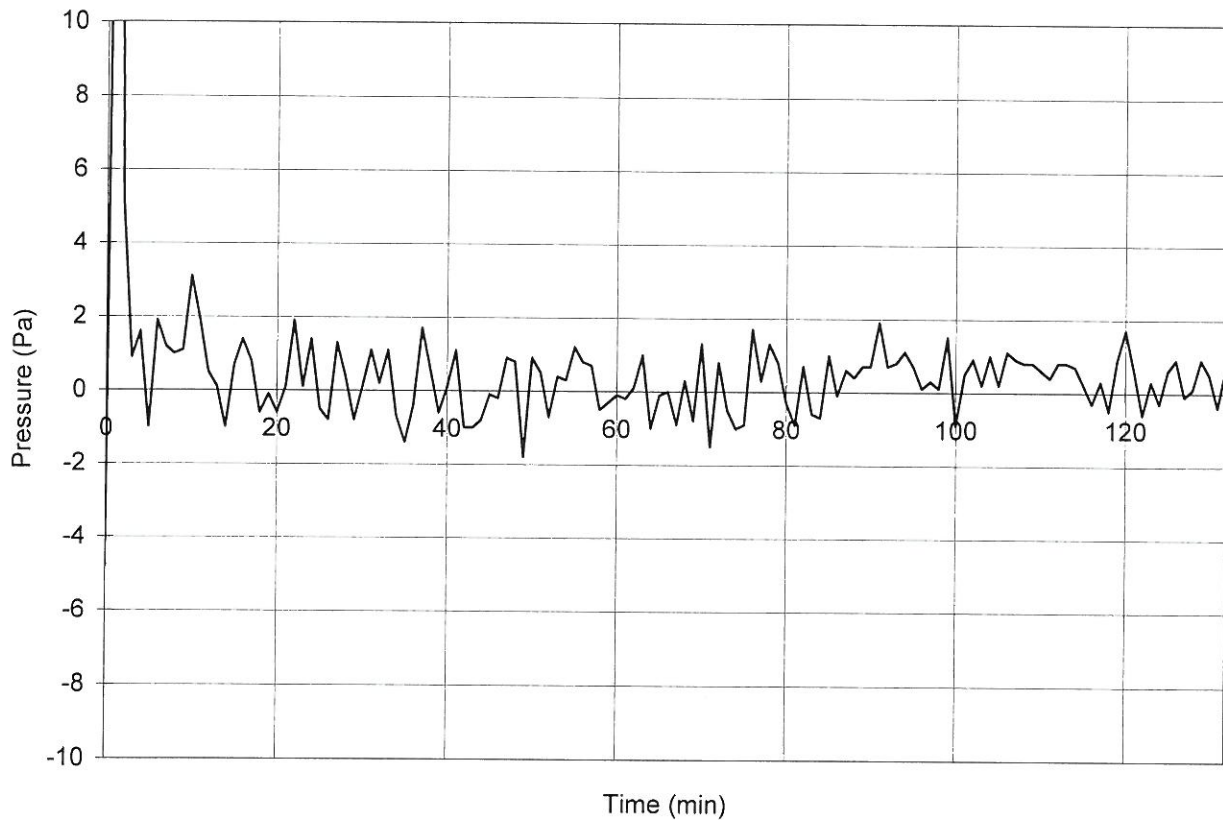
Figure 10 - Furnace Pressures Relative to the Laboratory Atmosphere

Graph showing recorded furnace pressure at 2030 mm below the top of the specimen.

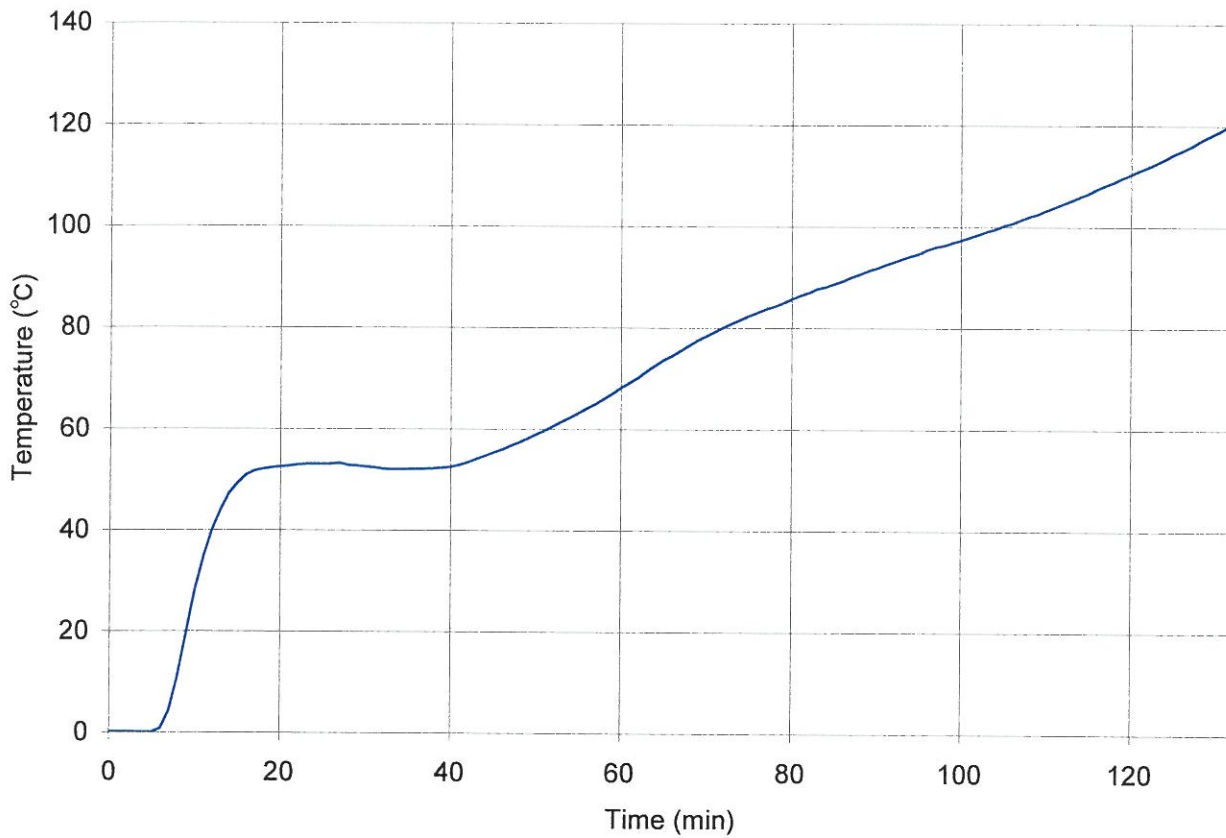
Figure 11 - Average Temperature Rise of the Unexposed Surface of the Specimen

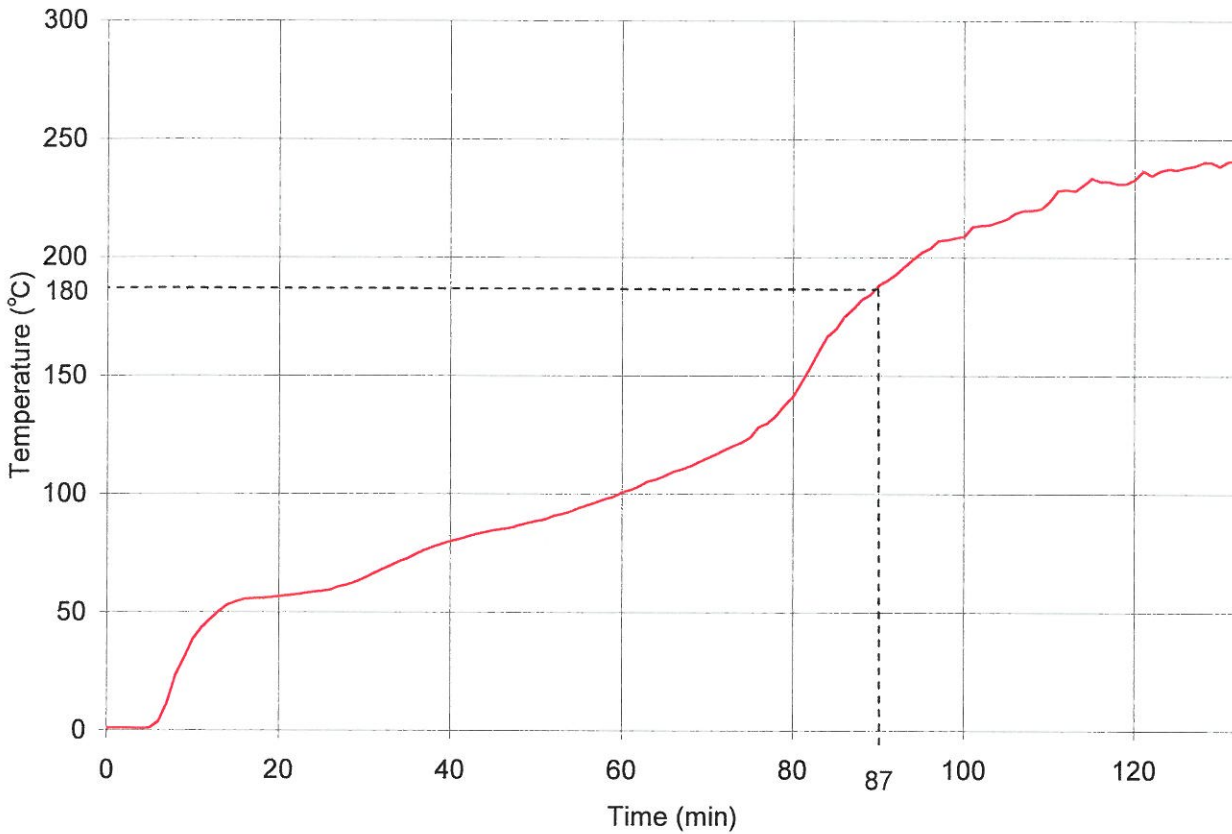
Figure 12 - Maximum Temperature Rise of the Unexposed Surface of the Specimen

81:30	The gap between the boards continues to increase at the vertical joint near thermocouple 10. Black discolouration is visible at the position.
87:54	Thermocouple 10 is recorded a temperature of 204.6°C, in excess of 180°C above the initial mean unexposed surface temperature of 2.4°C. <b>Insulation failure of the specimen</b> is deemed to occur.

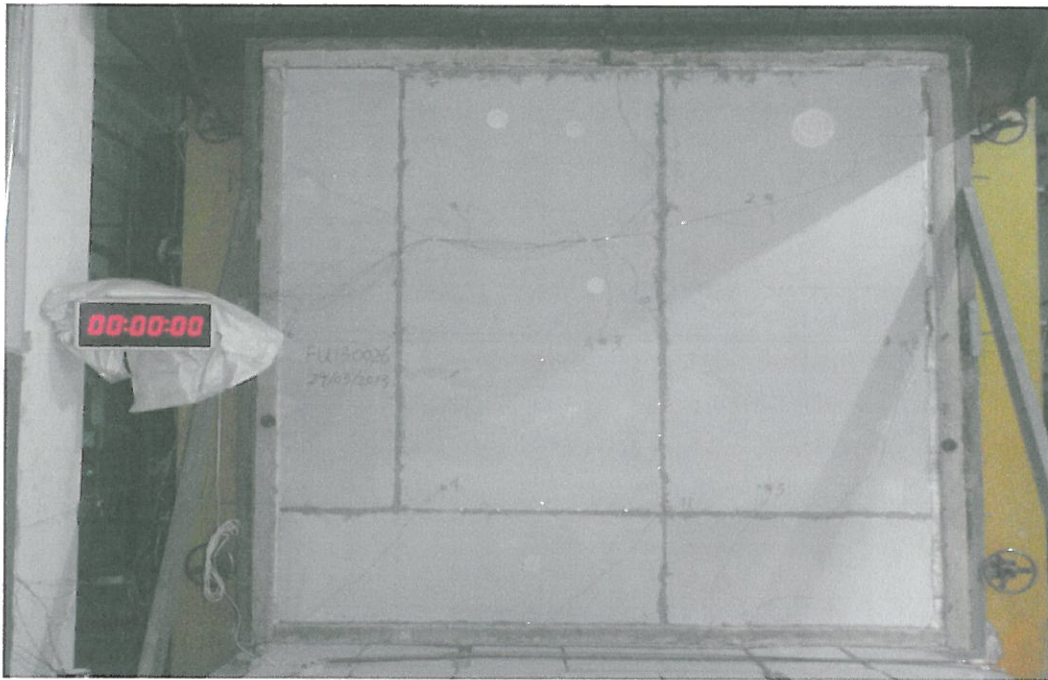
Photo 1 - The unexposed surface of the specimen before the test

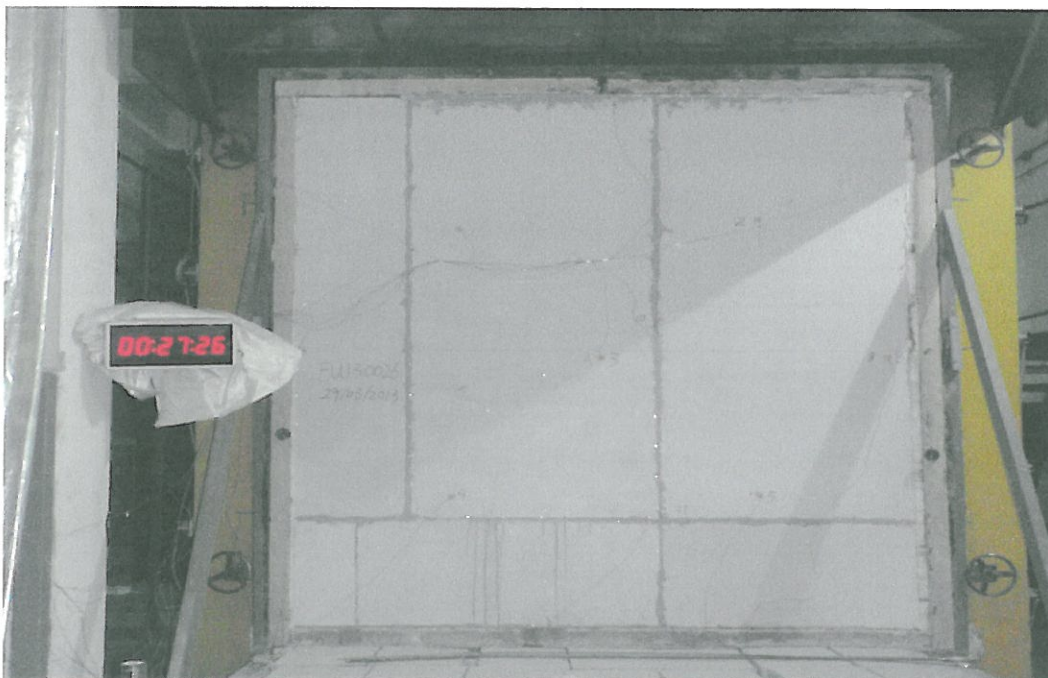
Photo 2 - The unexposed surface of the specimen during the test

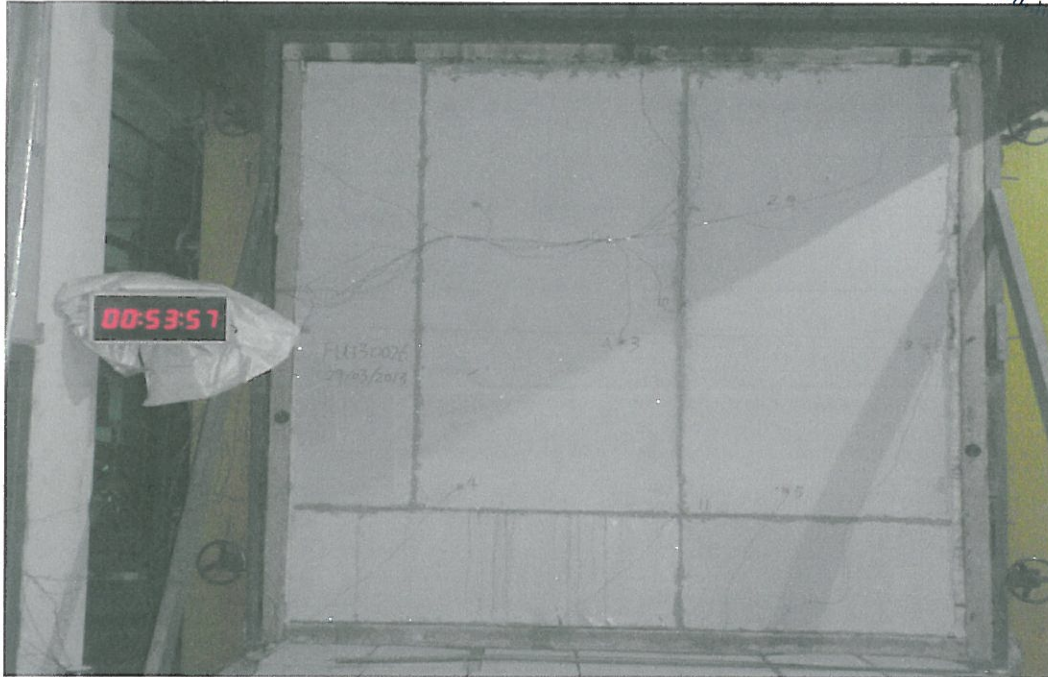
Photo 3 - The unexposed surface of the specimen during the test

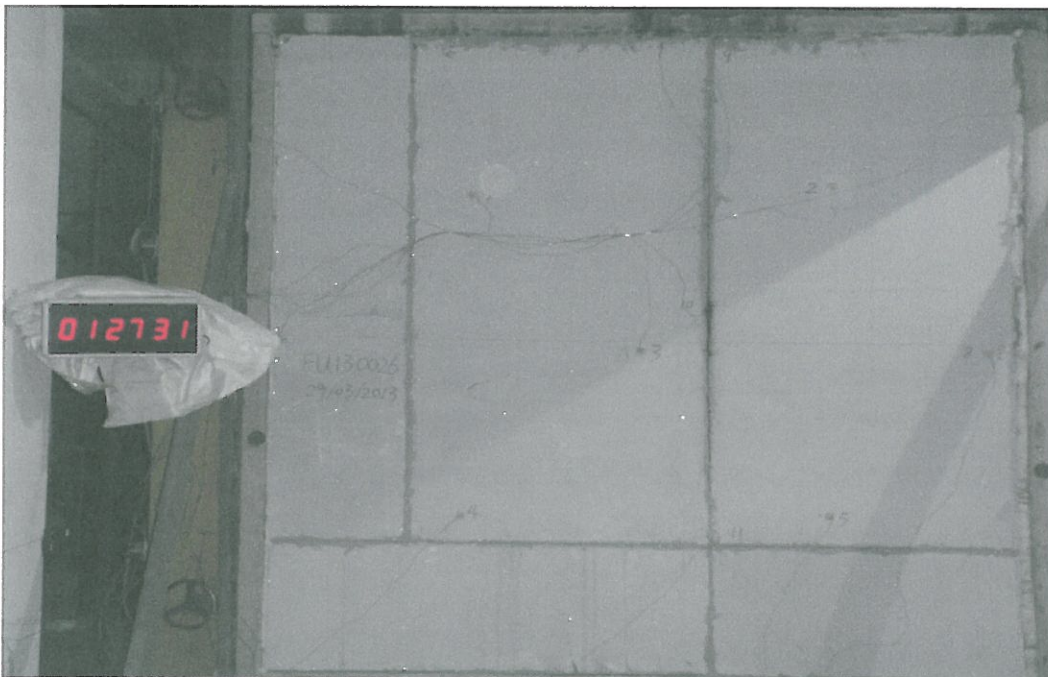
Photo 4 - The unexposed surface of the specimen during the test

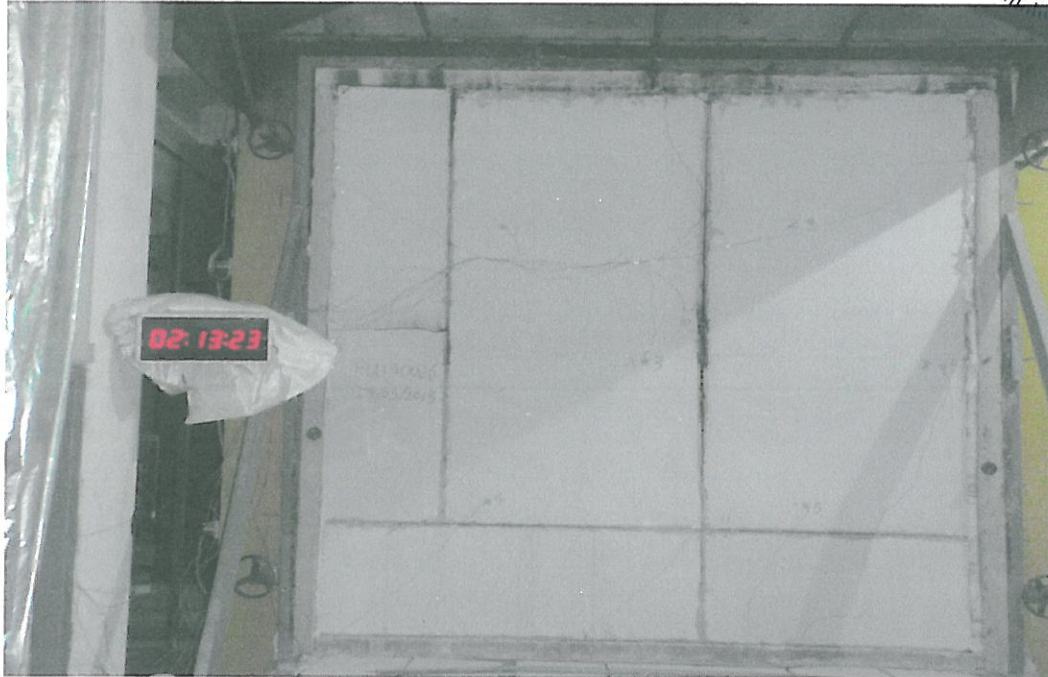
Photo 5 - The unexposed surface of the specimen after the test

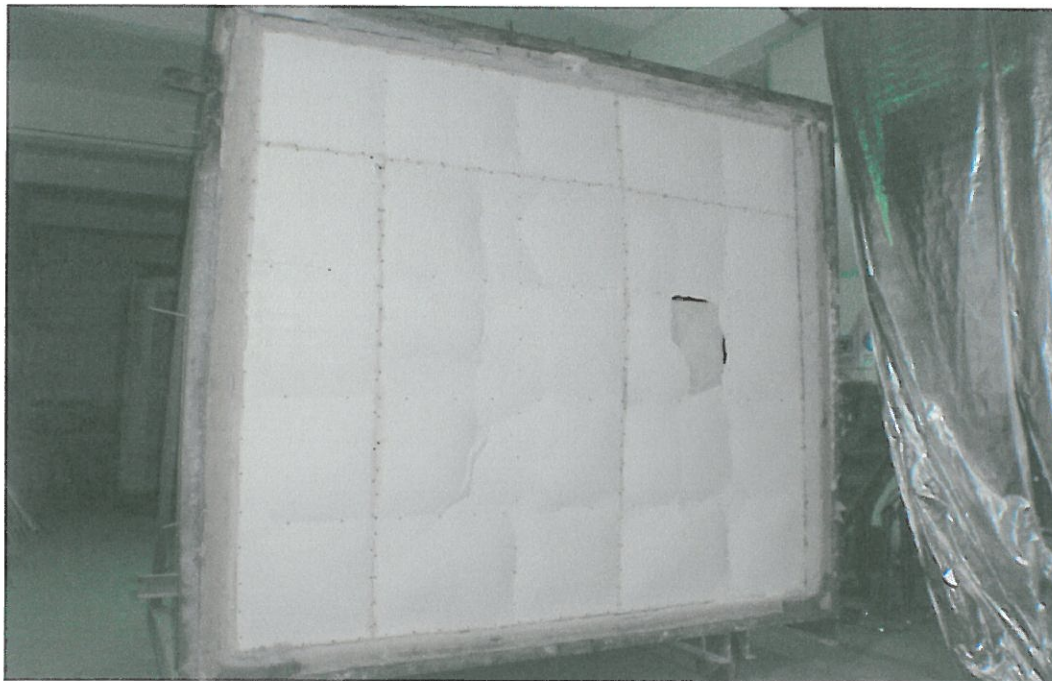
Photo 6 - The exposed surface of the specimen after the test
